***Phenolic Foam Roofing by Gary S Mays – Professional Roofing Consultant
Forwarded by Scott Fischer CRP***

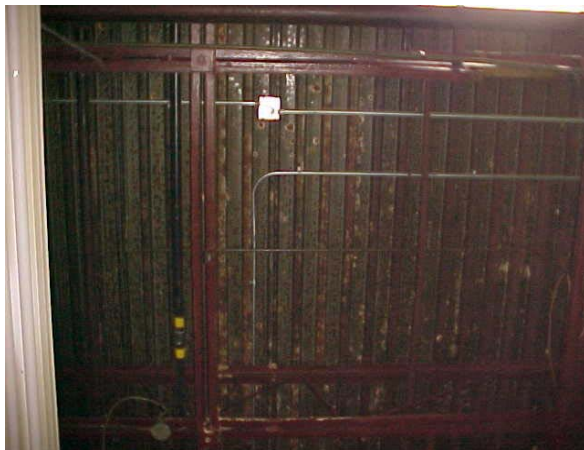
Roof Deck Corrosion

Unlike other plastic foam insulations, Phenolic Foam readily absorbs water and has been noted in some installations to shrink excessively. Joints in the insulation have been found in some installations to have opened to as much as 1-1/2 inches wide from an original butted condition. Corrosion is found to be typically more severe at the edges of the insulation boards where condensate-producing conditions occur within the voids.

Research indicates that the United States-based Phenolic Foam technology used an aromatic sulfonic acid as a catalyst in the process to create the cells of the foam. It appears that the high rate of water absorption by the Phenolic Foam allows the water to dissolve the sulfonic acid, forming a highly-acidic compound. This highly-acidic compound readily breaks down the typical structural metal deck and metal roof component coatings (organic and inorganic). It has also been reported that formic acid gaseous vapors are also released from Phenolic Foam insulation, thus contributing to the corrosion process of metals in the immediate vicinity of the phenolic material. Once the coatings have been destroyed, the corrosion of steel progresses at an accelerated rate.

When a small amount of water is leaking in, or as in condensate-producing conditions found in high relative humidity applications, the Phenolic Foam seems to act like a sponge. When water saturates the Phenolic Foam insulation, it picks up chemicals out of the insulation. As it exits the board, it is very corrosive (with a low pH factor in the 1.5 to 3.5 range). The low pH precipitant is highly corrosive to steel components found within the roof and roof structure (fasteners and structural steel). In addition, the structural steel roof deck which is in direct contact with the saturated Phenolic Foam insulation is highly susceptible to premature corrosion. When structural steel roof deck corrosion occurs, it can lead to an unsafe condition; and, if left uncorrected, it could lead to property damage or bodily injury.

Where evidence of Phenolic Foam insulation exists, caution should be exercised in traversing the roof. Where corrosive Phenolic Foam insulation is found within a roofing system, the insulation and all of its residue should be completely removed from the roof and roof structure. In addition, all severe corrosion-damaged structural steel should be removed and replaced with new materials. Minor structural steel deck corrosion can be arrested by completely removing the corrosion and applying a quality rust-inhibitive epoxy coating or equivalent protective coating system.
